1 Pace Plaza East Renovation - Progress Photos

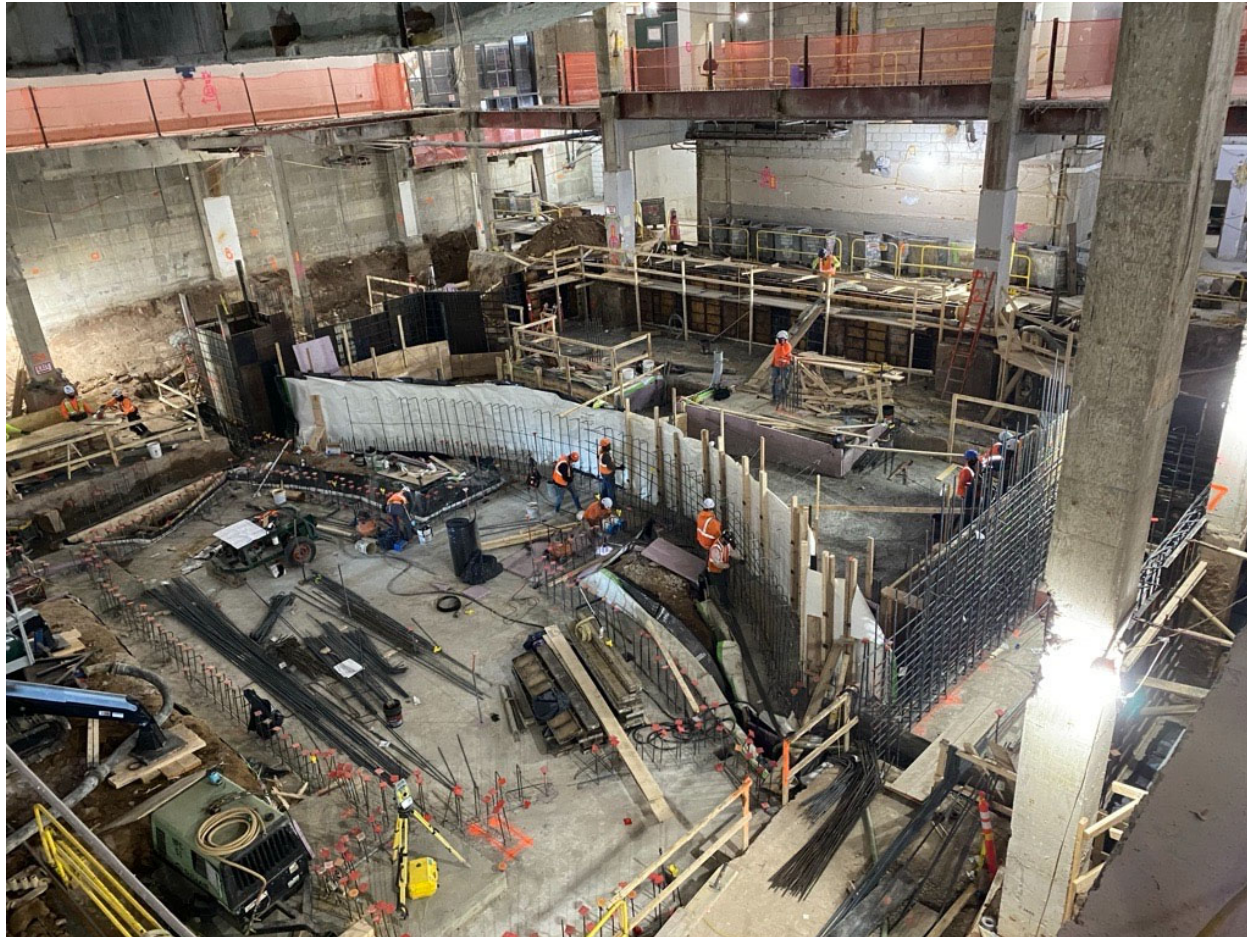
Rebar installation and concrete slab and footing pours ongoing in Large Venue.

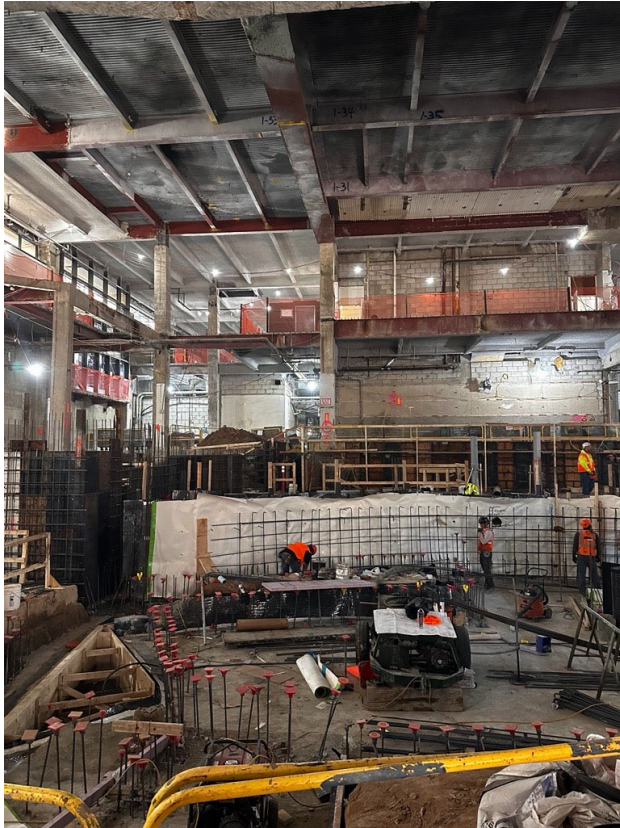
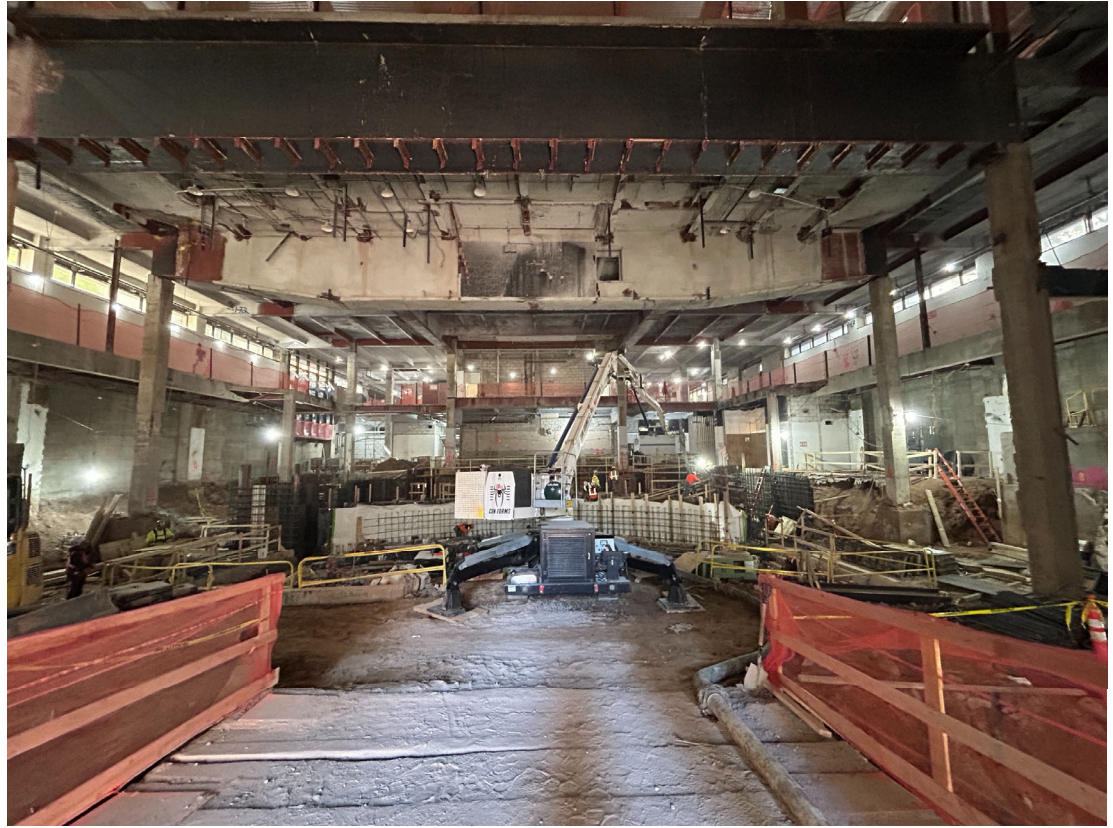
Rebar installation and concrete slab and footing pours ongoing in Large Venue.

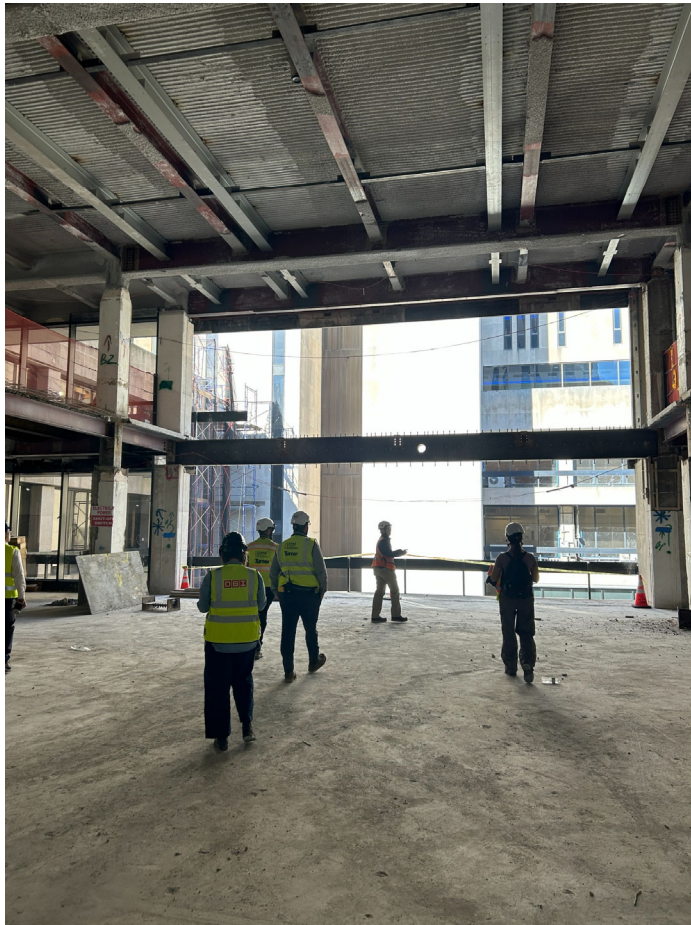
Façade demolition is complete for future Medium Venue.

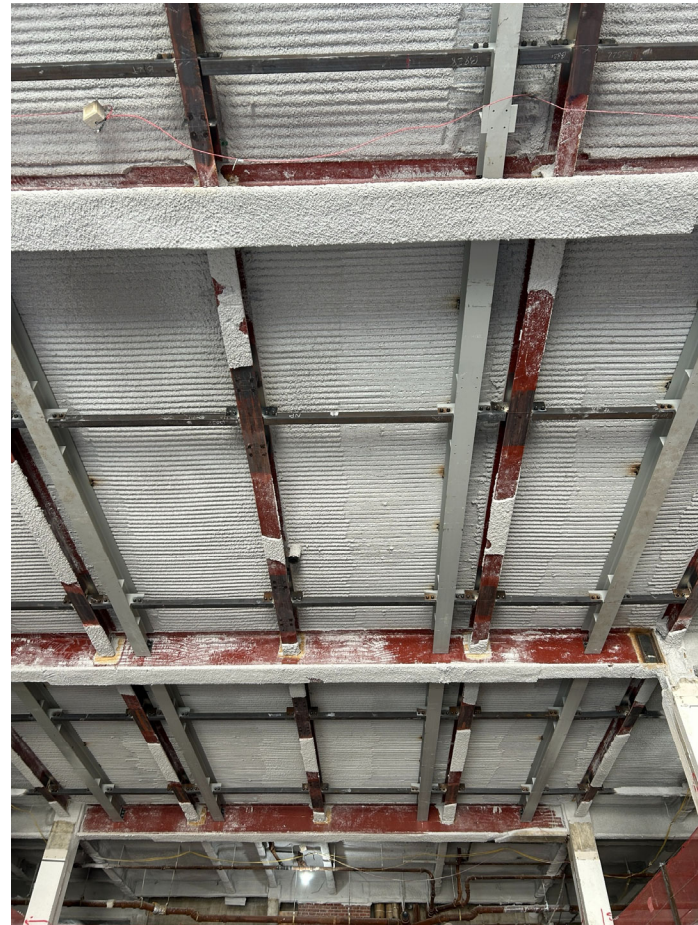
New structural steel installation at Medium Venue.

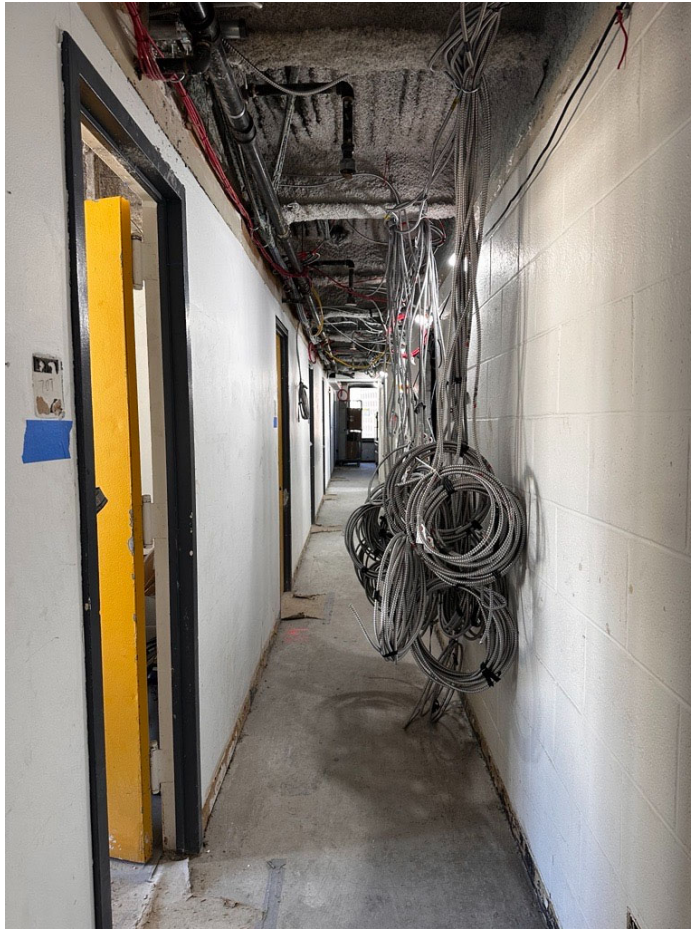
Electrical conduit installation in the Maria's Tower.

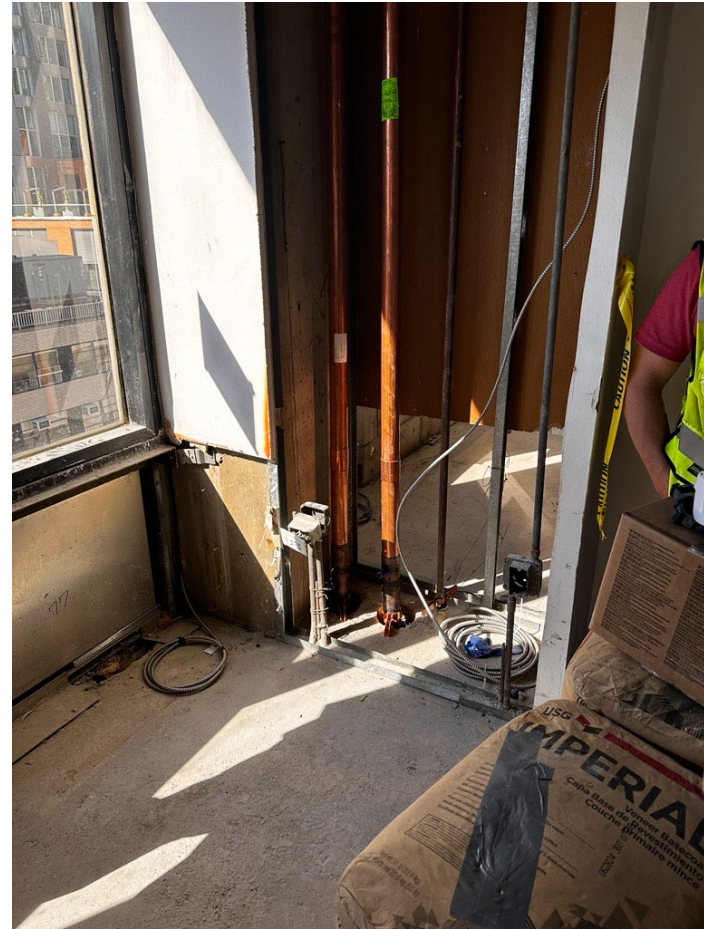
New mechanical riser installation in the Maria's Tower.
