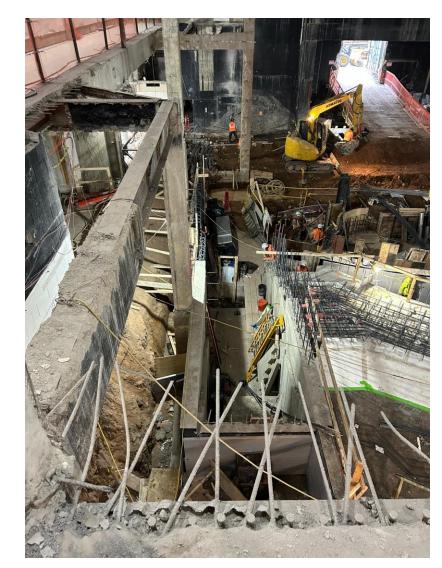
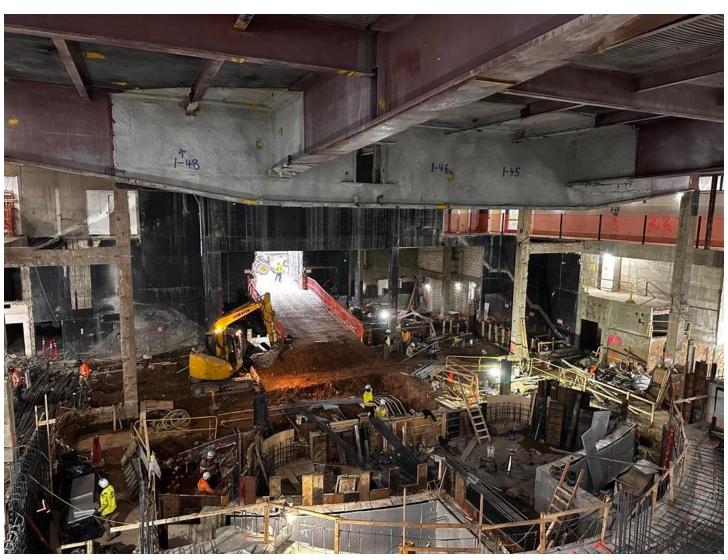
Continued rebar installation in the Large Venue in preparation for the concrete slab on grade.

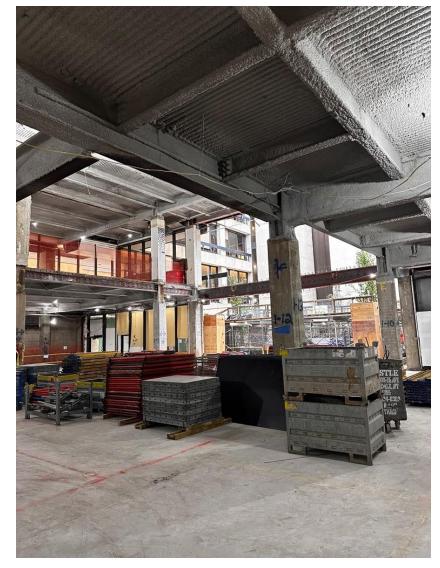
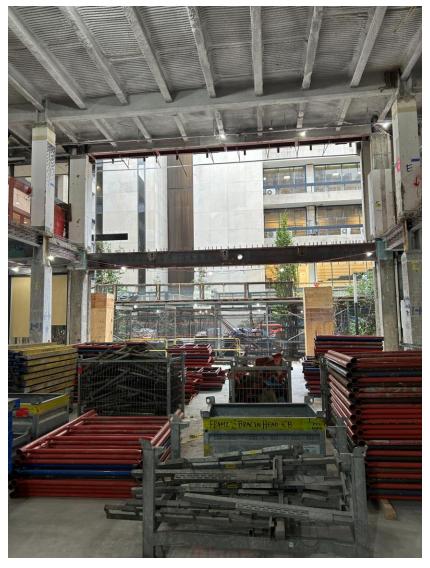
Small Venue opening on first floor with quick deck delivered on site.

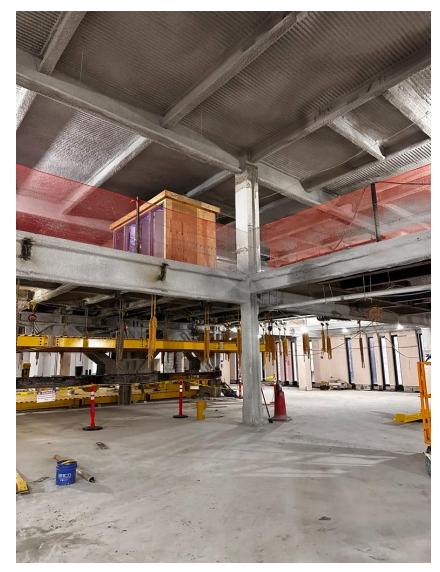
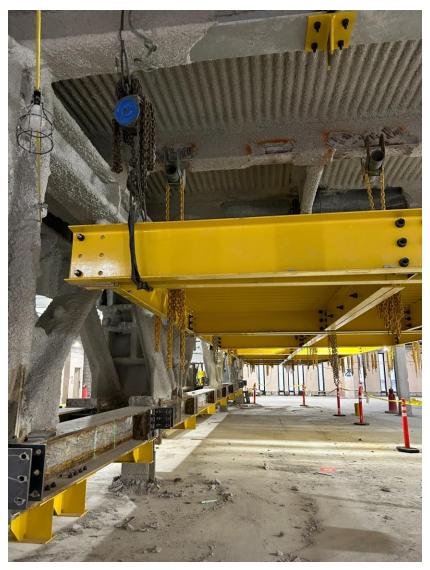
Grid iron being temporarily hung on the 2nd floor.

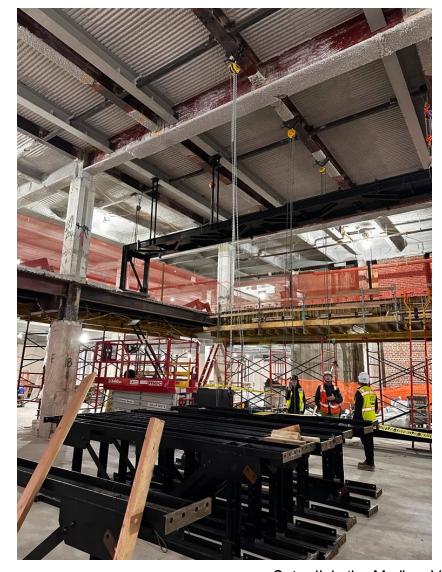
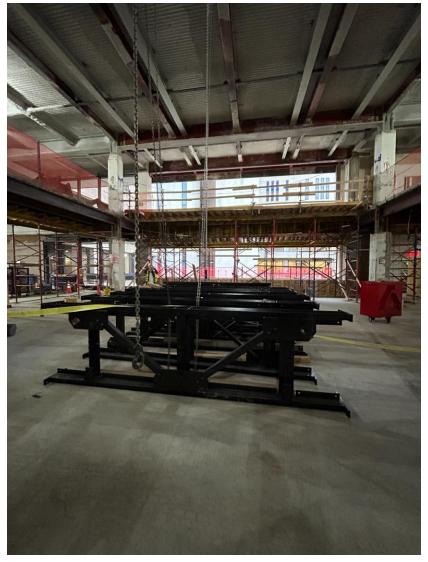
Catwalk in the Medium Venue has arrived on site.
