# 1 Pace Plaza East Renovation - Progress Photos

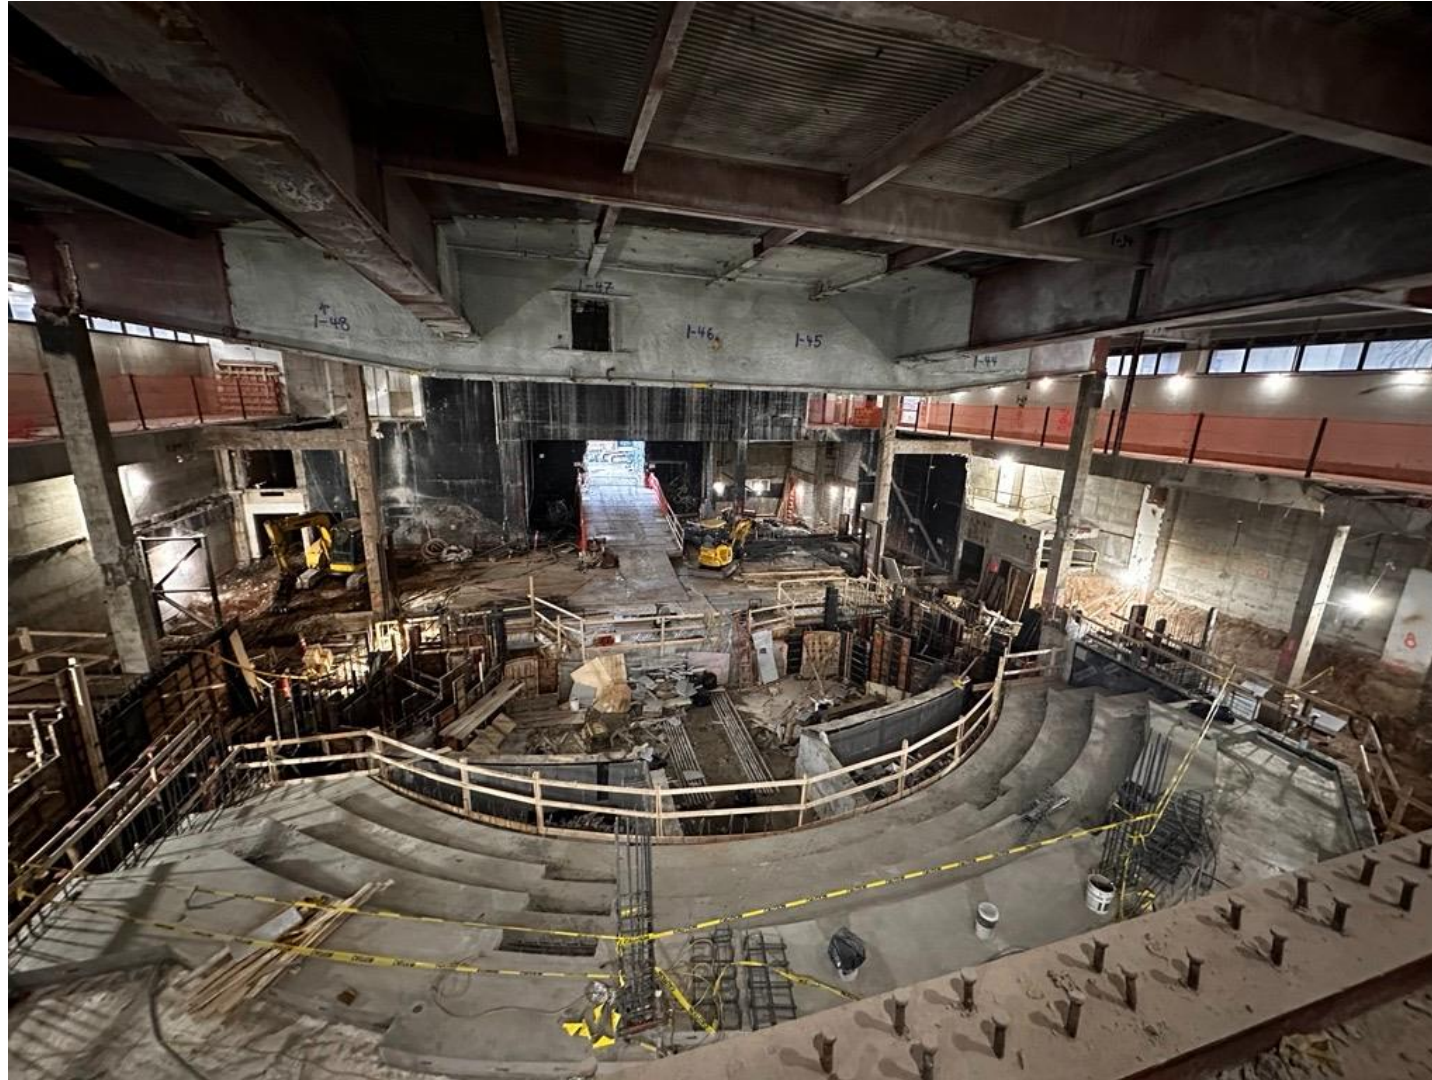
Concrete pour in balcony seating. Protections have been installed over the new stage slab in preparation for overhead structural demolition.

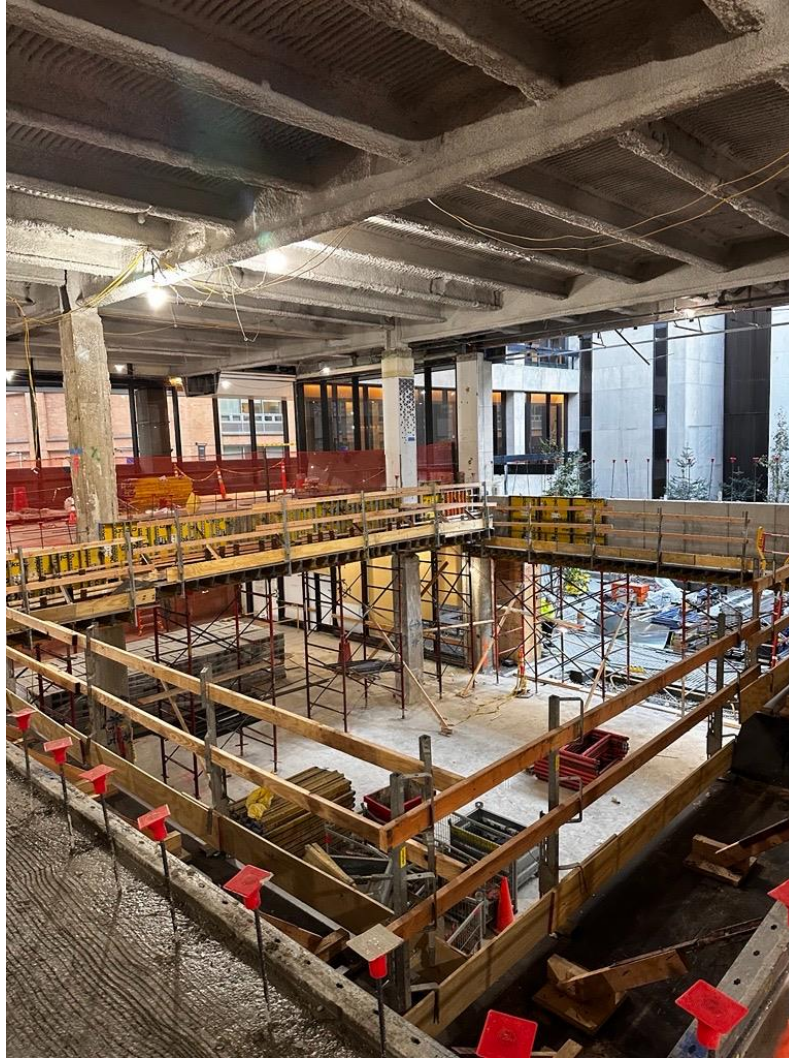
Preparation for Small Venue CMU wall installation.

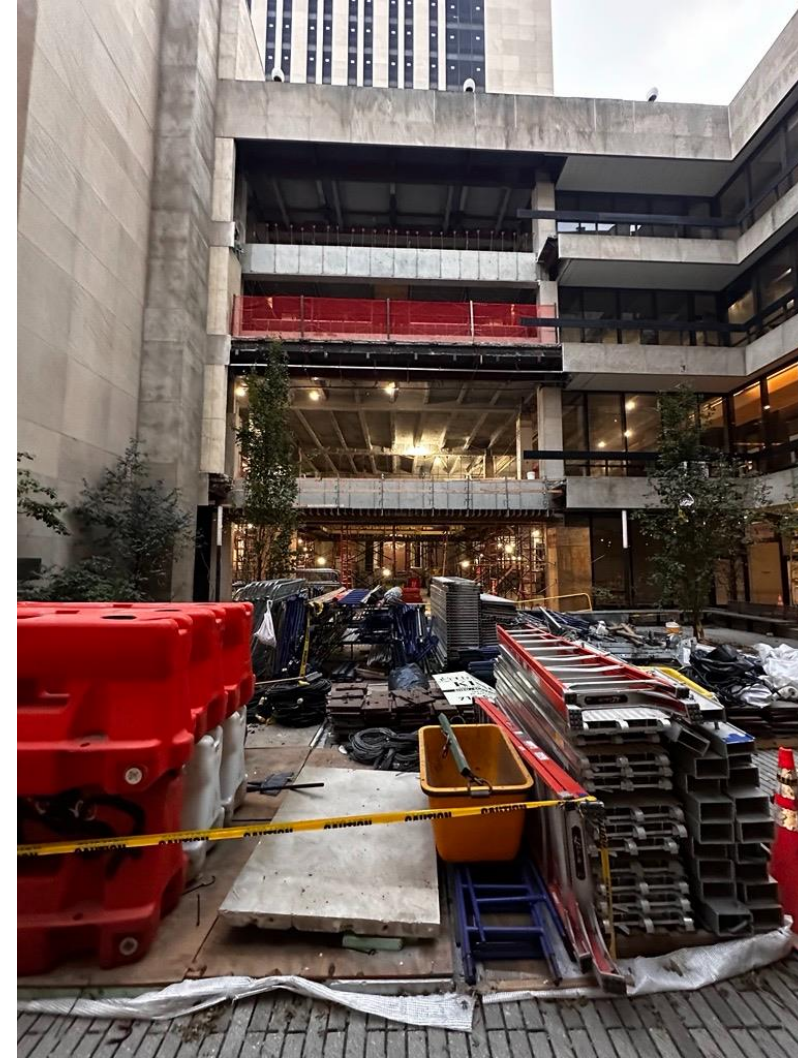
View of Small and Medium Venues from the Courtyard.

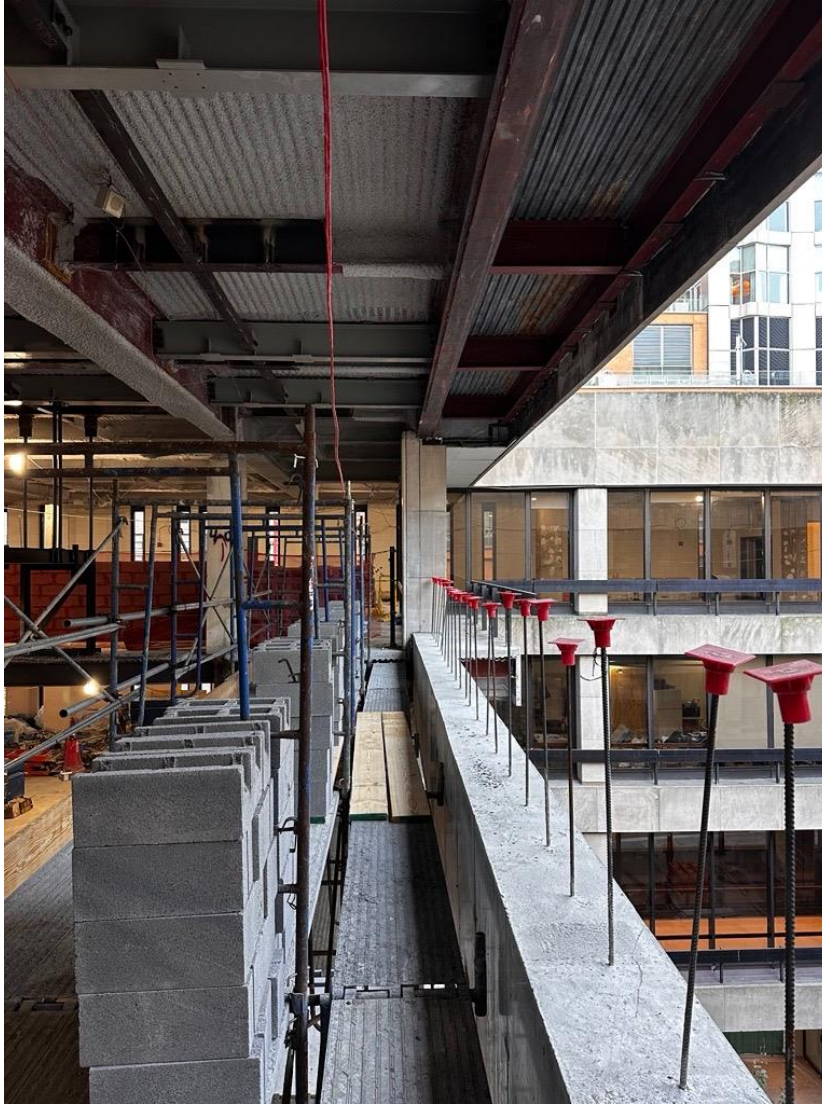
CMU wall work ongoing at venue openings.

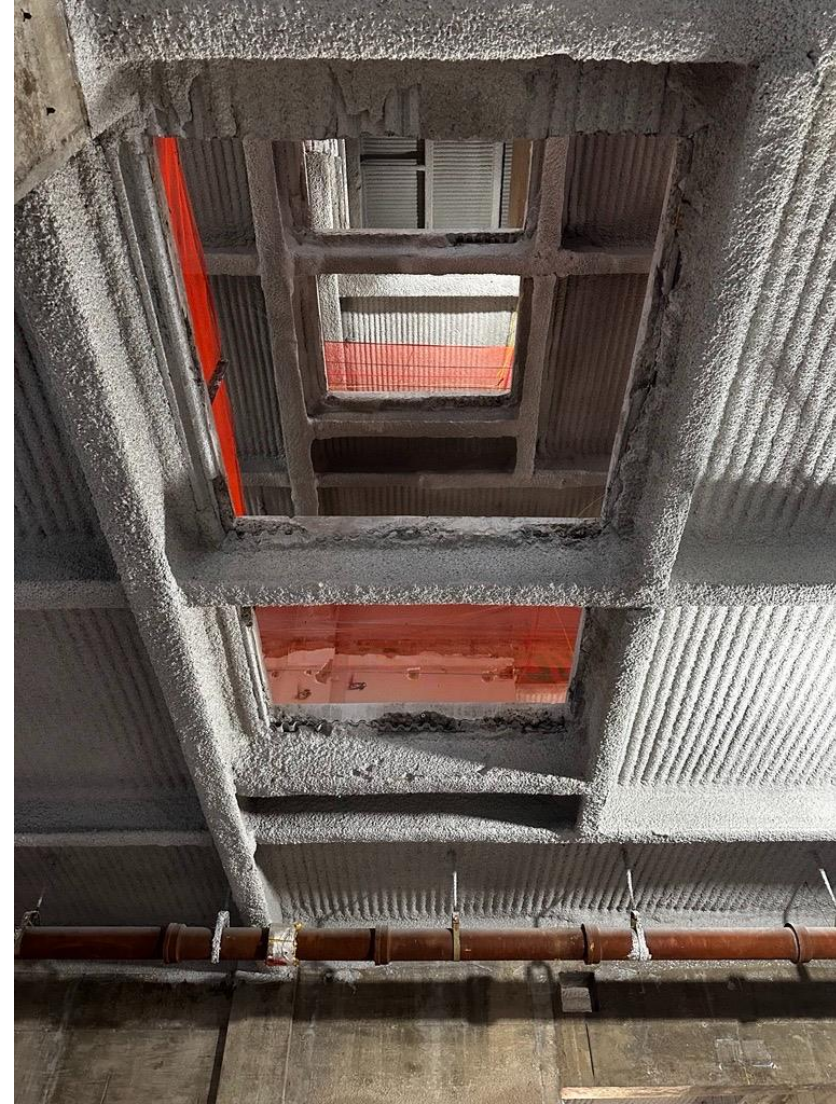
Slab openings for utilities and ductwork.

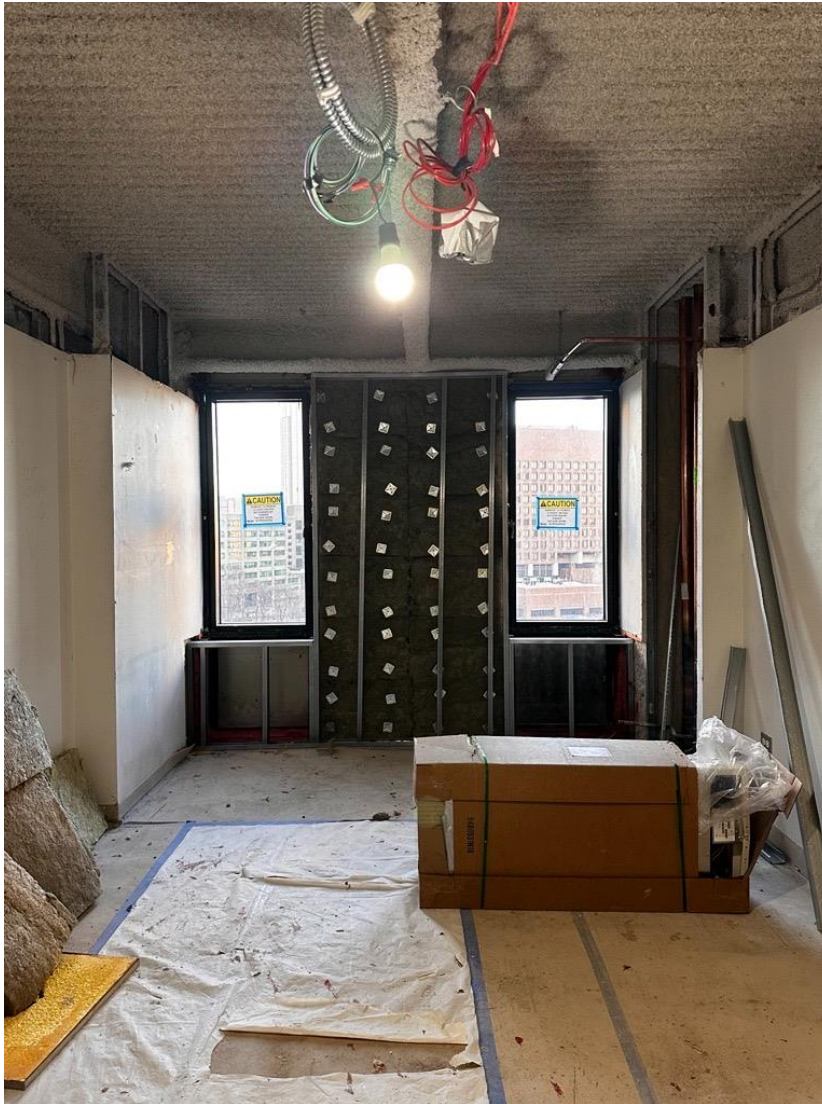
Perimeter insulation installation is ongoing in Maria's Tower.

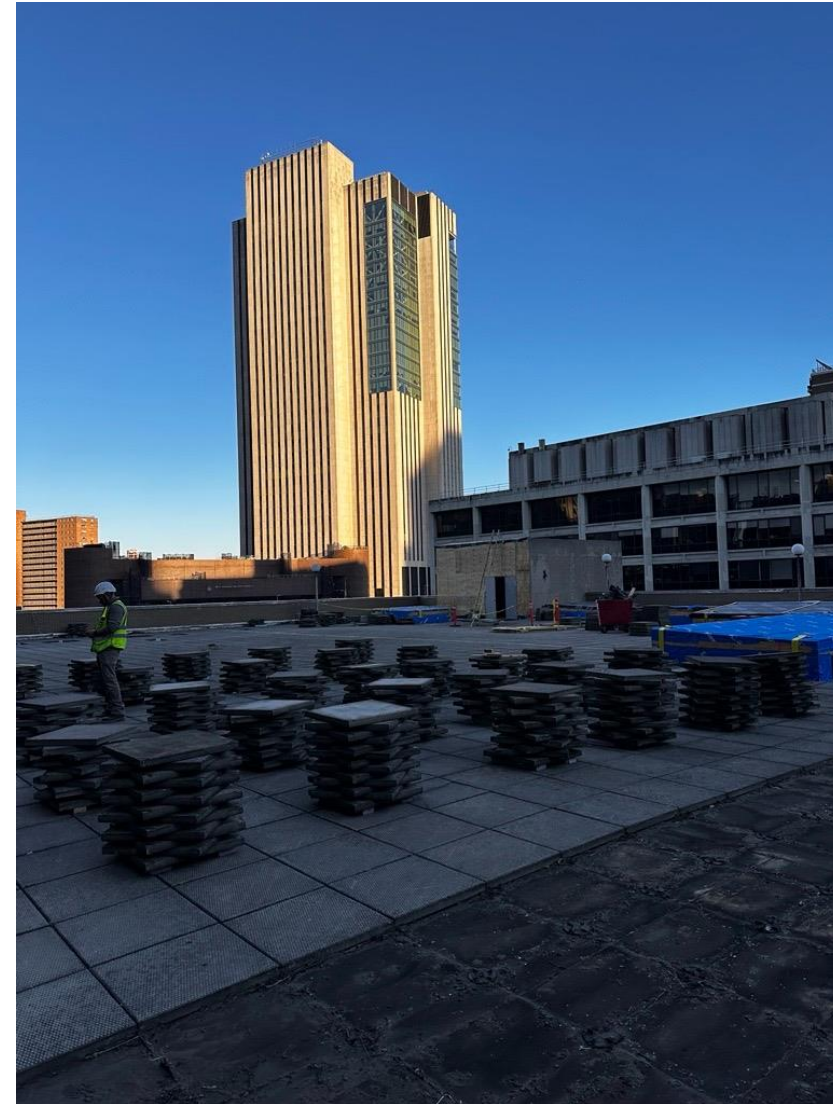
4th Floor paver removal for roof work.
