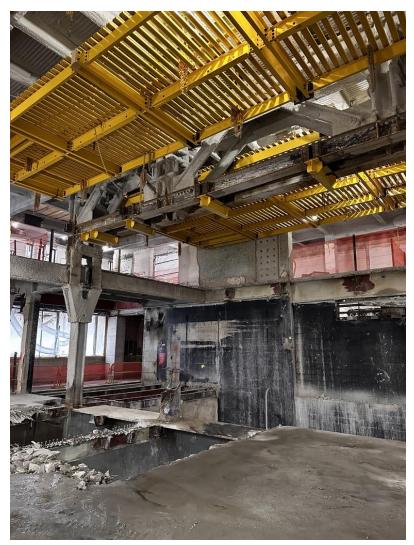
Ongoing structural demolition at the Large Venue.

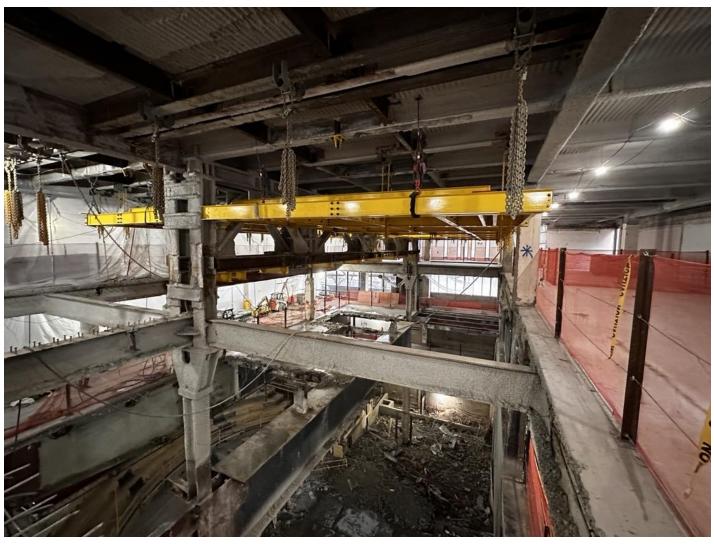
View of structural demolition in Large Venue from 2nd Floor looking north.

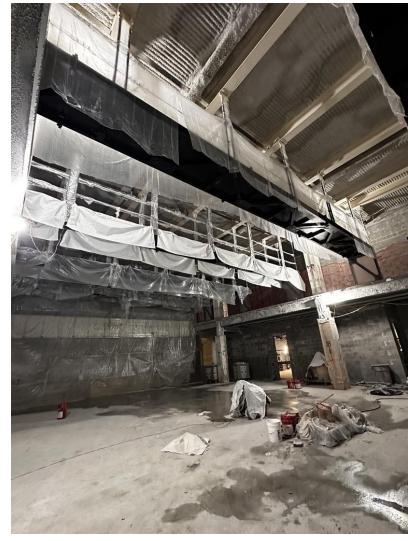
Installation of intumescent paint the in the Medium Venue.

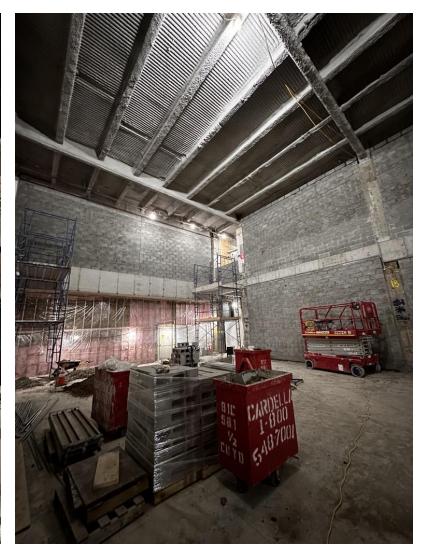
New CMU wall progress in the Small Venue.

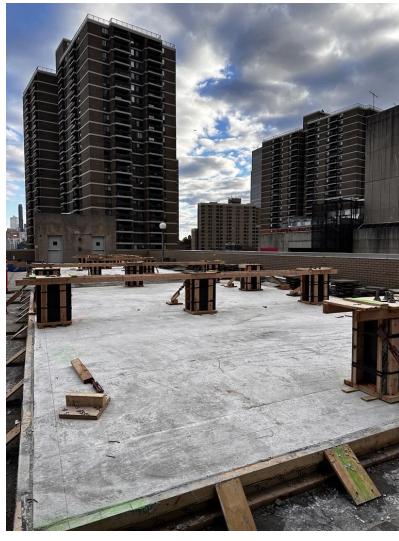
New concrete pad installation for new HVAC equipment on the 4th Floor roof.

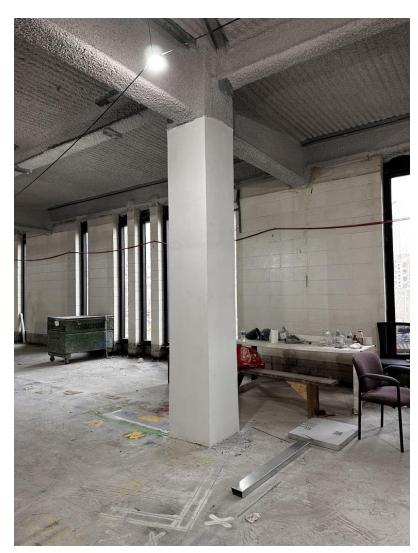
Plaster column finish mockup on the 3rd Floor.

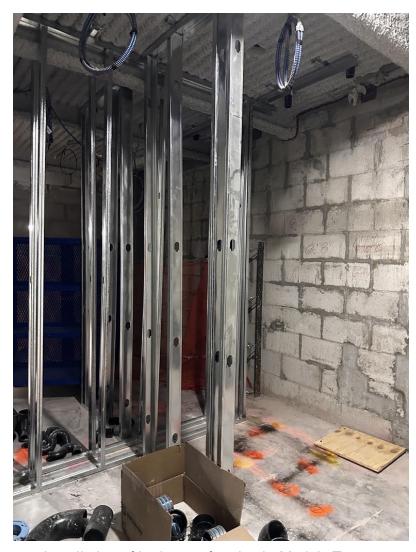
Installation of bathroom framing in Maria's Tower.

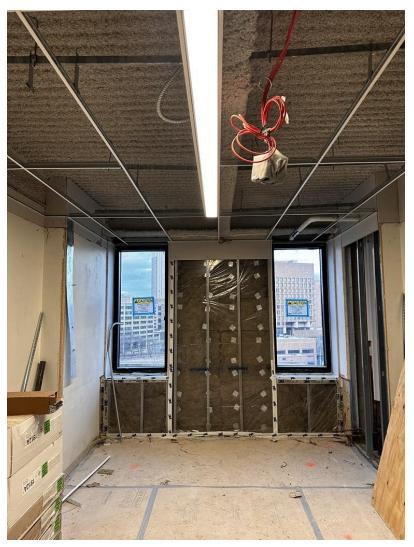
Installation of ceiling grid and lighting in Maria's Tower.
