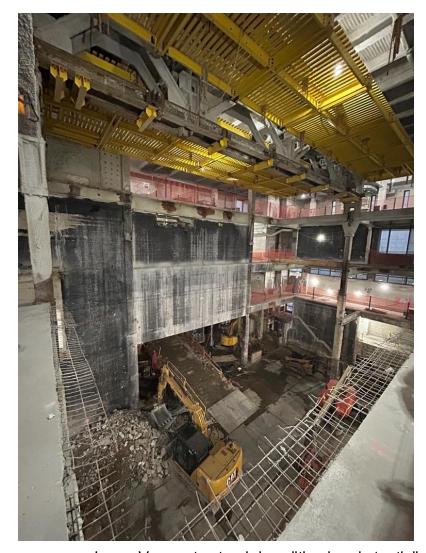
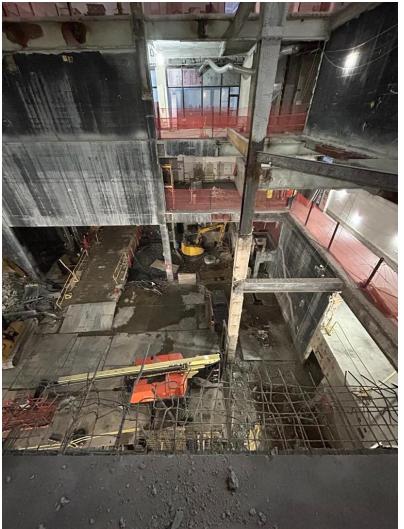
1

Large Venue structural demolition is substantially complete. Existing truss has been demolished.

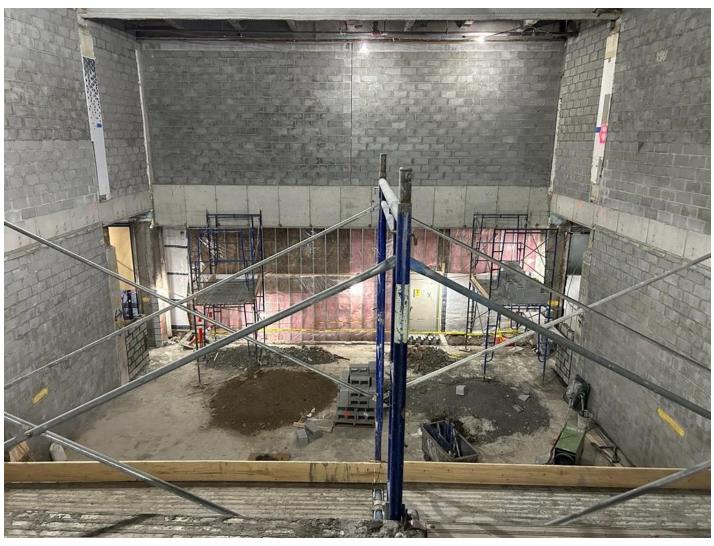
View of Small Venue from 1st Floor.

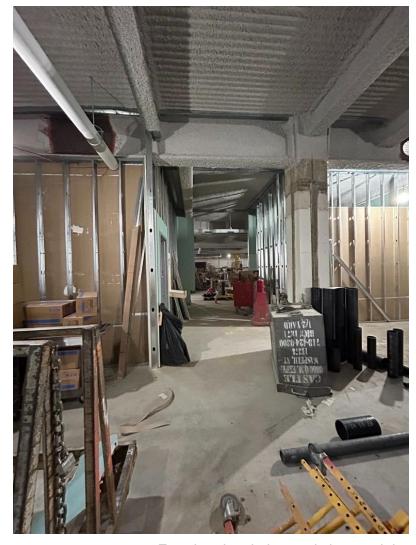
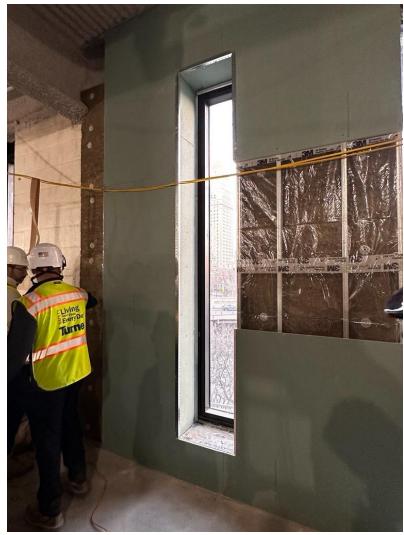
3

Framing, insulation and sheetrock installation on the 3rd Floor in the Podium.

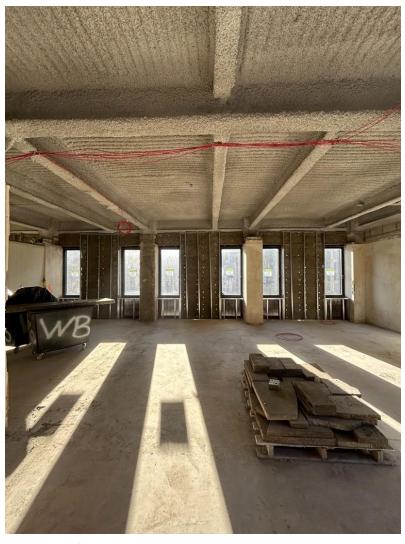
18th Floor insulation installation is ongoing.

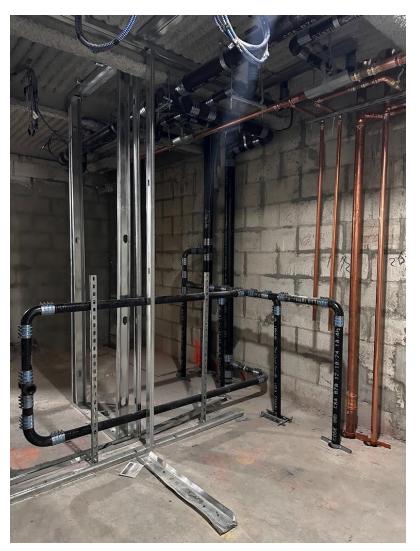
Maria's Tower bathroom framing and pipe installation.
