1 Pace Plaza East Renovation - Progress Photos

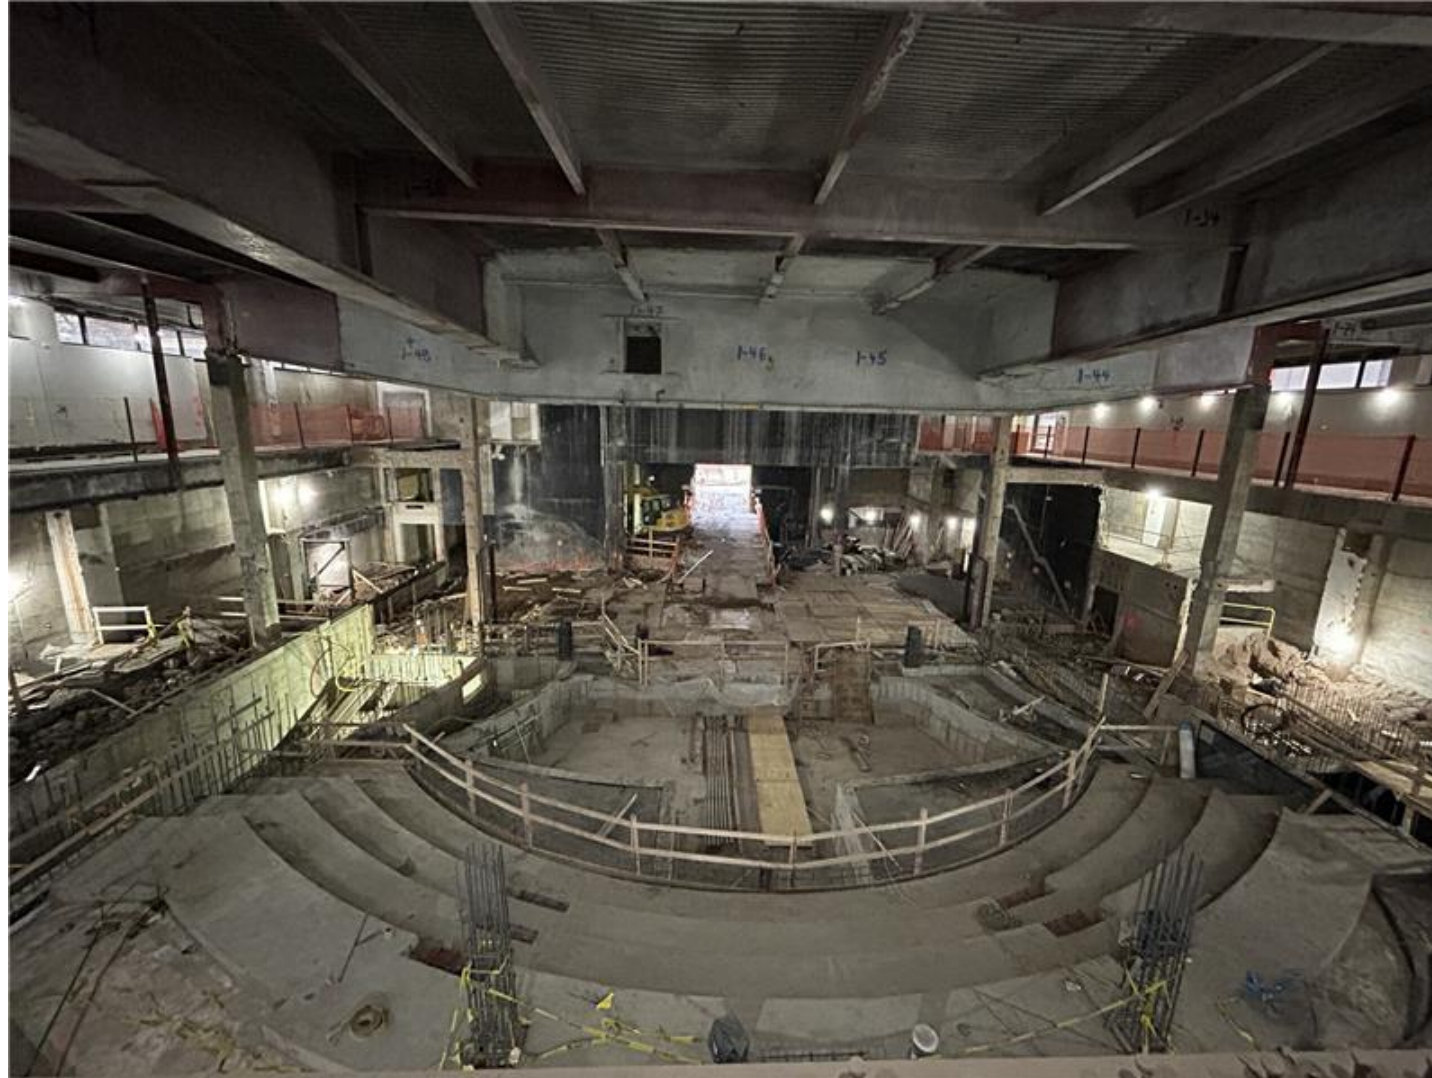
Overhead structural demolition began this week, protections are installed on the new stage slab.

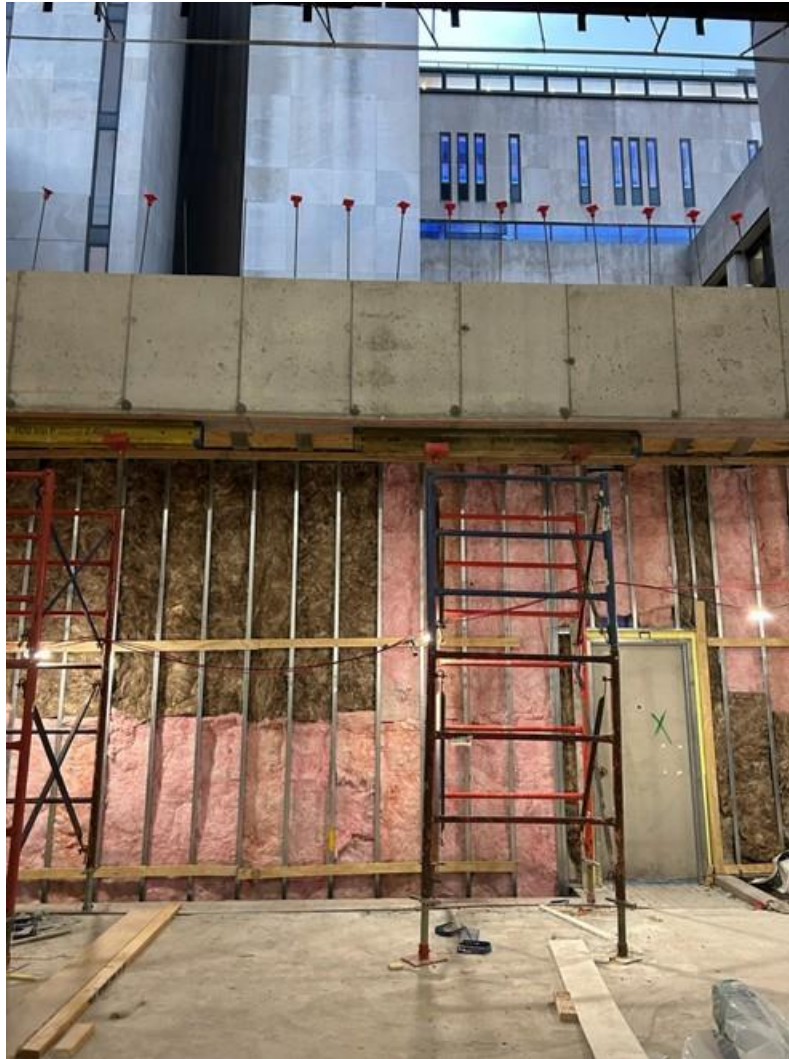
View of Small Venue weather wall from interior looking out at PPW courtyard.

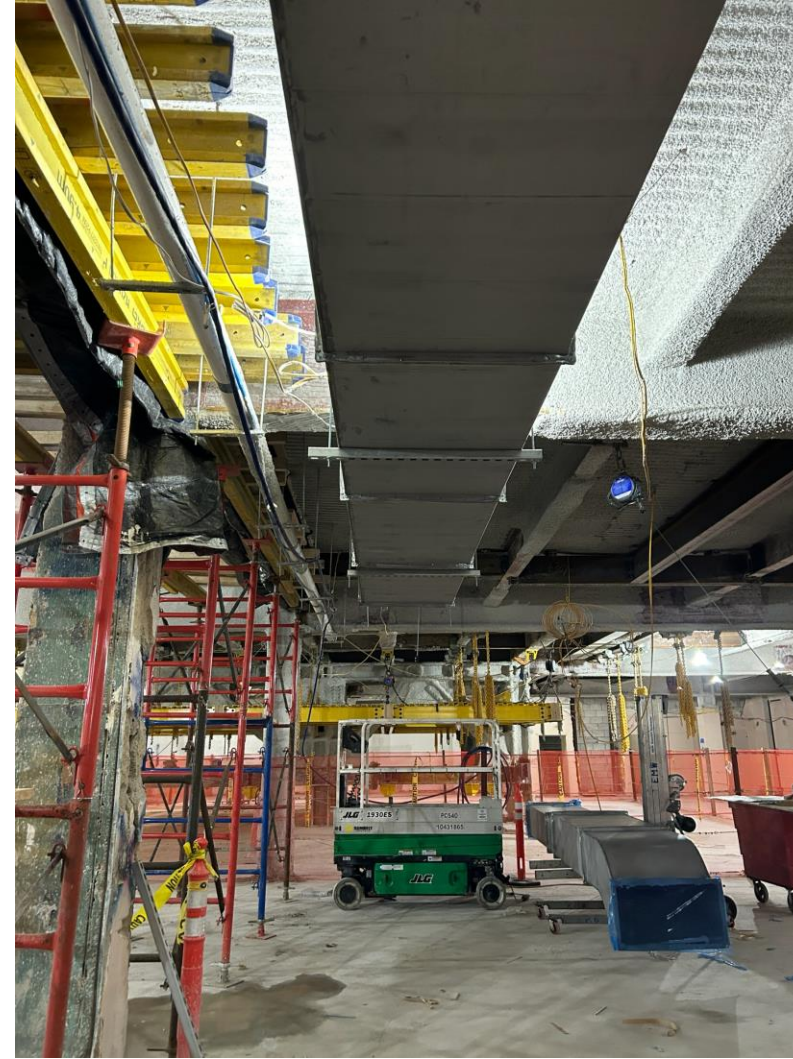
Ductwork installation has started on the 2nd Floor.

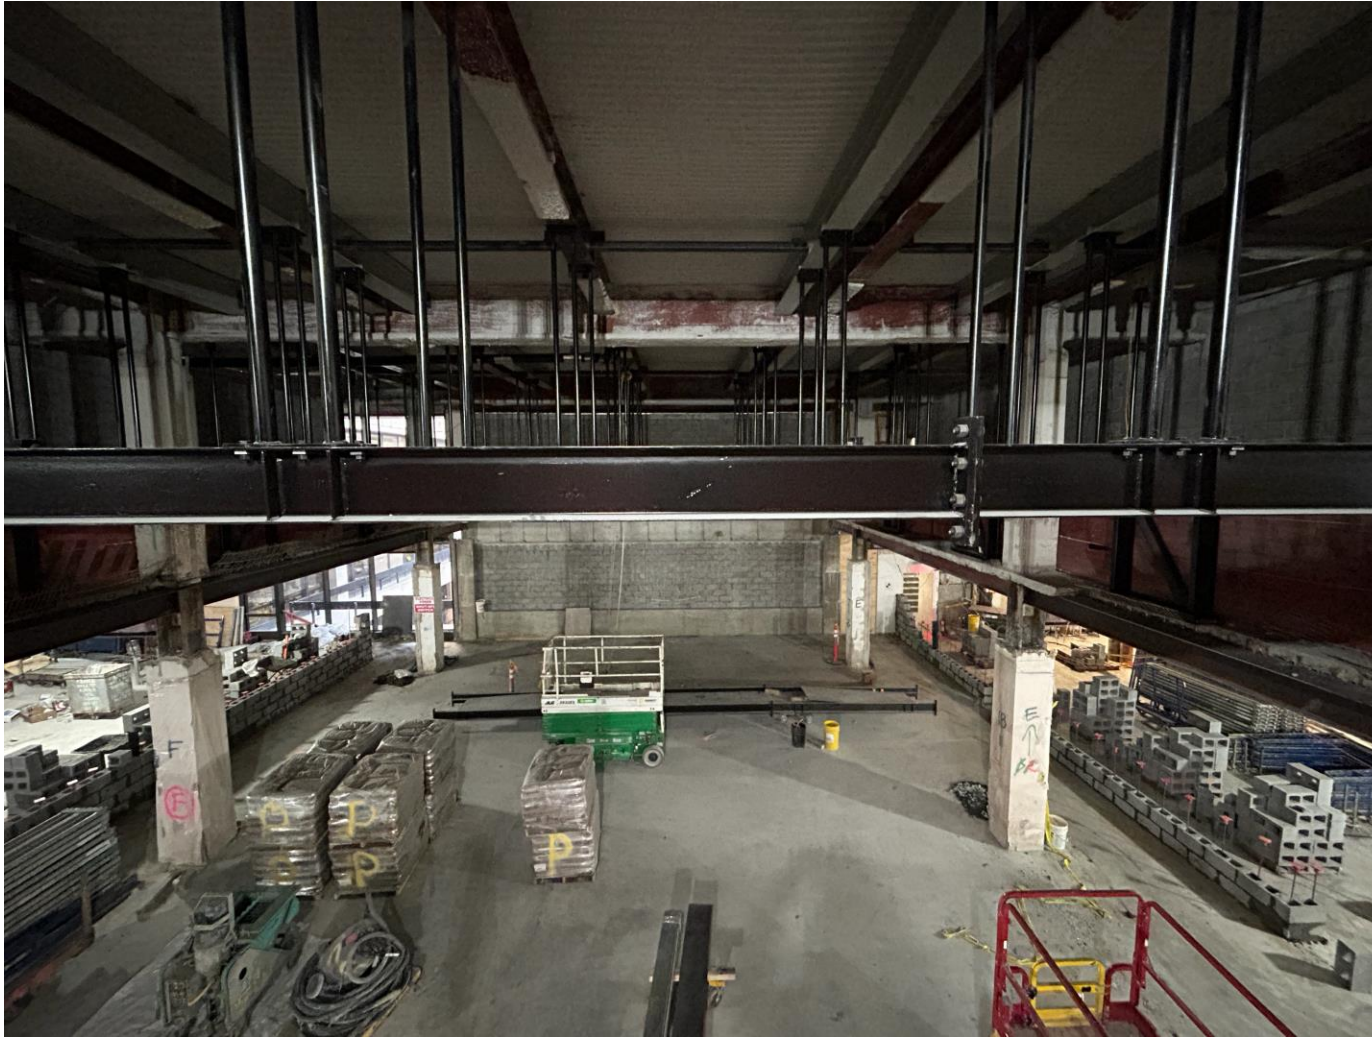
View of Medium Venue from 3rd Floor.

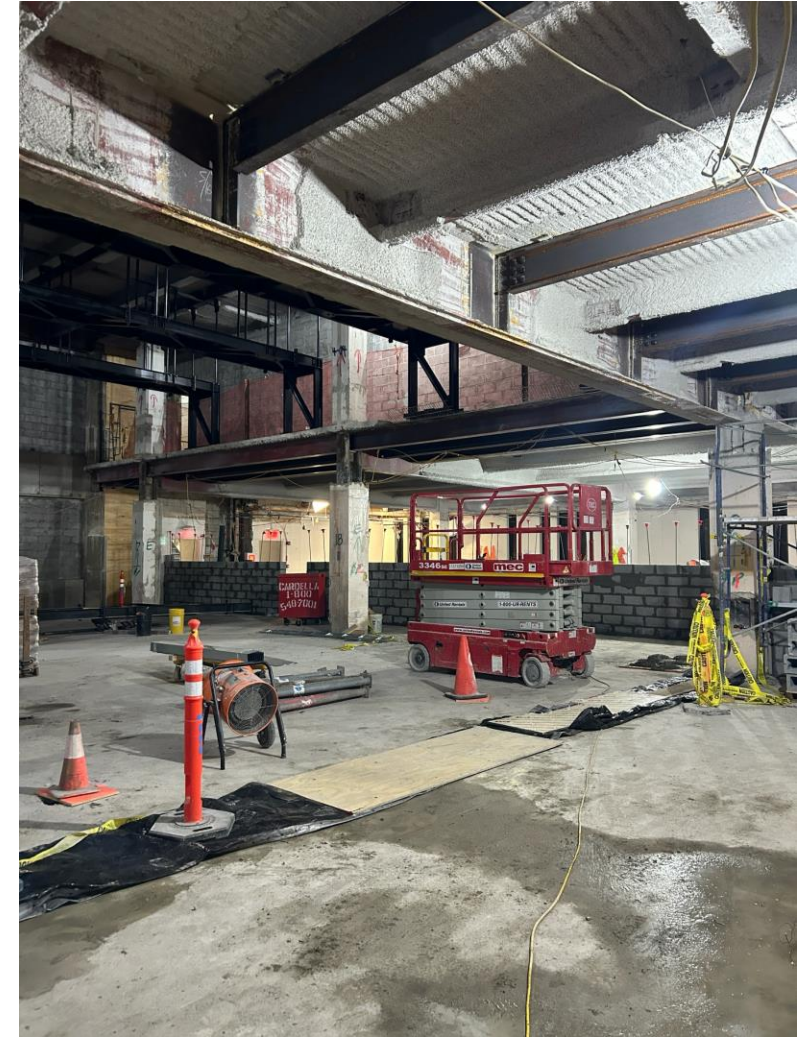
Medium Venue CMU wall installation.

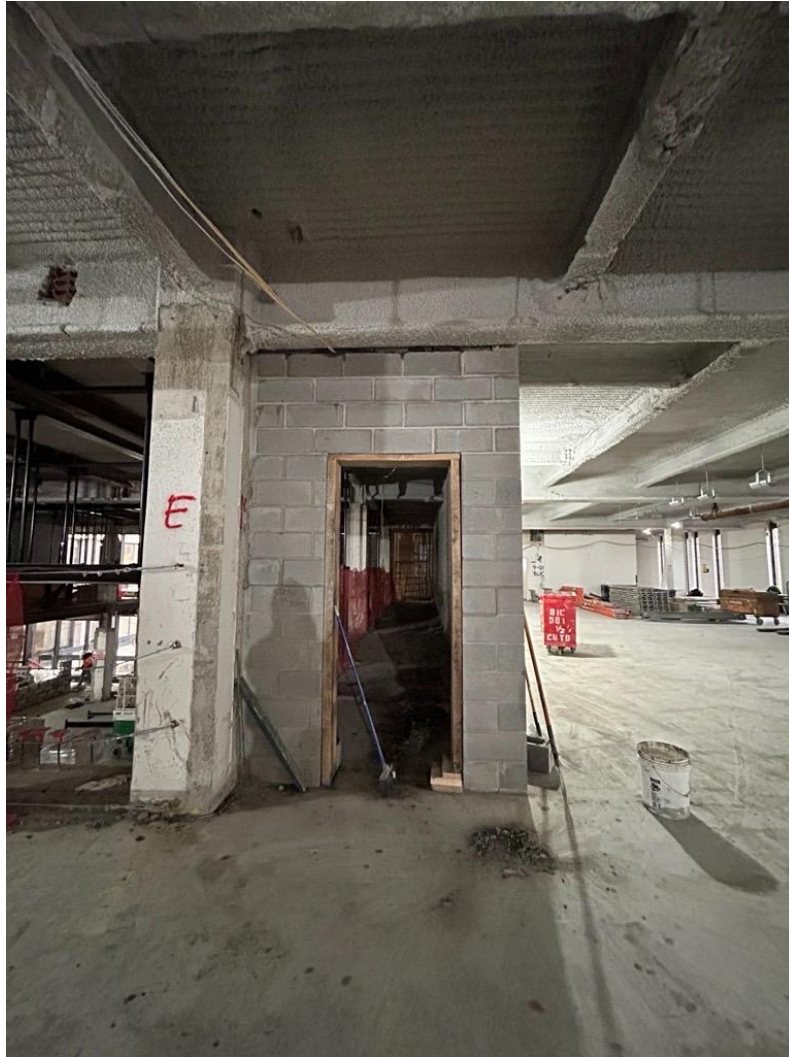
Medium Venue gallery CMU walls complete.

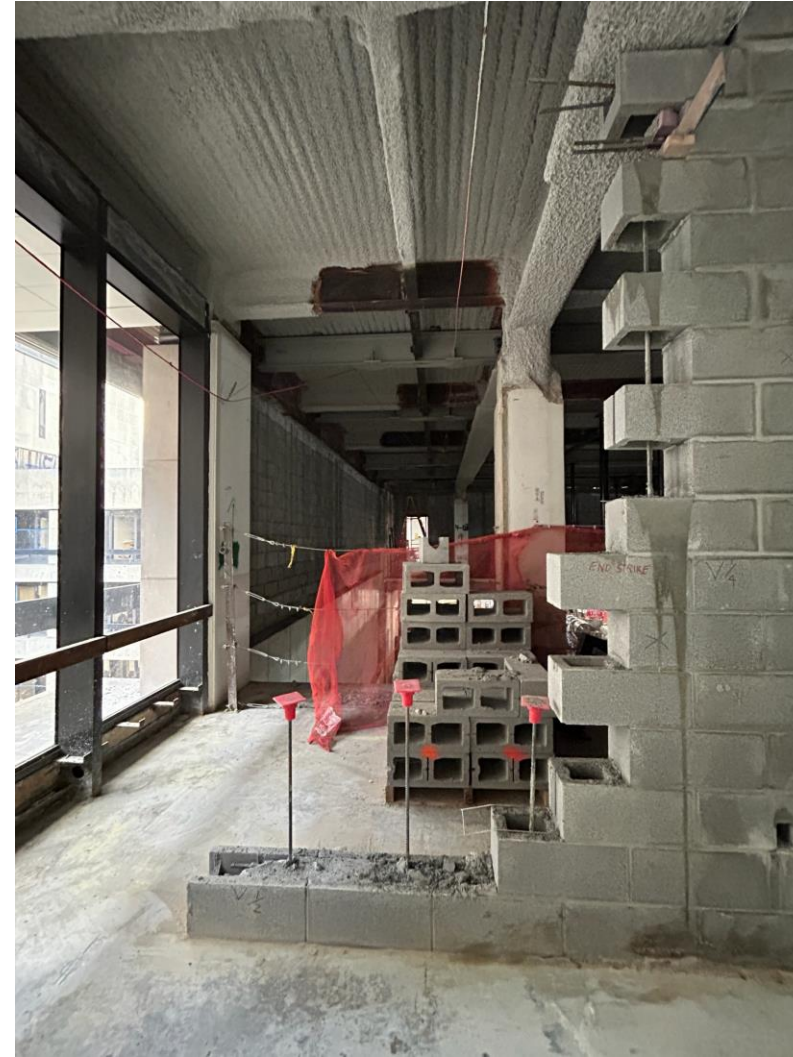
CMU block wall installation ongoing throughout.
